BUCKEYE LAKE FEEDER CHANNEL

HISTORY AND FUTURE PERSPECTIVES

Prepared by The Watershed Committee of the Buckeye Lake Region Corporation.

Fact Sheet

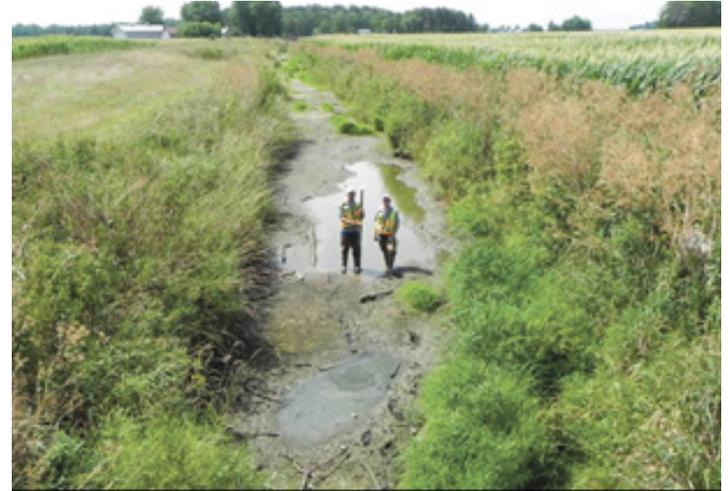
Nutrient-rich sediment deposits within the Buckeye Lake Feeder Channel

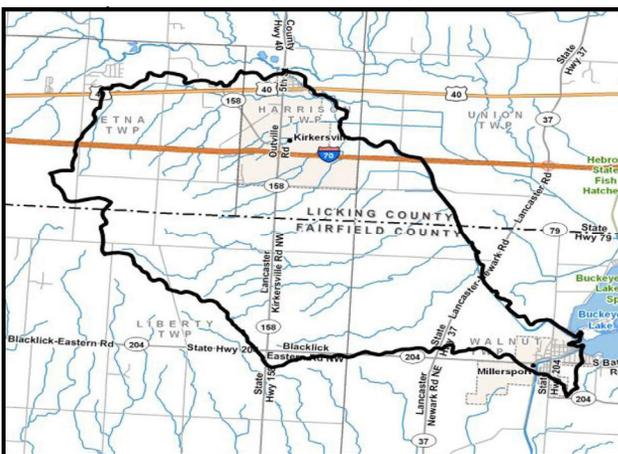
Approximate watershed boundary for the Buckeye Lake Feeder Channel

The Feeder Channel is the primary tributary feeding Buckeye Lake. It has a watershed area estimated to be between 12 and 17 square miles, comprising approximately 40% of the total watershed area to the lake. This includes a portion of Interstate 70, which has been exposed to flooding and also has contributed to the water quality impairments in the Feeder Channel and Buckeye Lake.

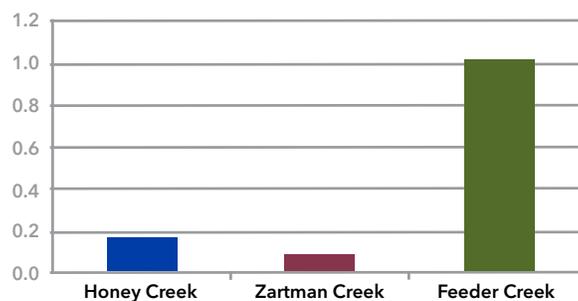
Unit Area Loads – TP (kg/d/mi²)
(2008-2012 average) *

* More recent samples have shown a decline in Phosphorous due to conservation practices in the watershed.

- 1) Buckeye Lake is challenged by a lack of sufficient source water to support lake levels throughout the drier and hotter summer months. *Improvements to the Feeder Channel represent one of the few opportunities to increase source water to the lake.*
- 2) The Feeder Channel is a major external source of nutrients pollution to the lake. The graphic created by the Ohio EPA demonstrates measured Total Phosphorous (one of the primary nutrient pollutants) loading from the Feeder Channel compared to two other channels that contribute water to Buckeye Lake. Historically, the Feeder Channel is estimated to have contributed more than 20 percent of the annual phosphorous loading to the lake. *The abundance of phosphorous in the lake contributes to the growth of algae during the hotter summer months, representing a risk to aquatic organisms and a threat to human health.*

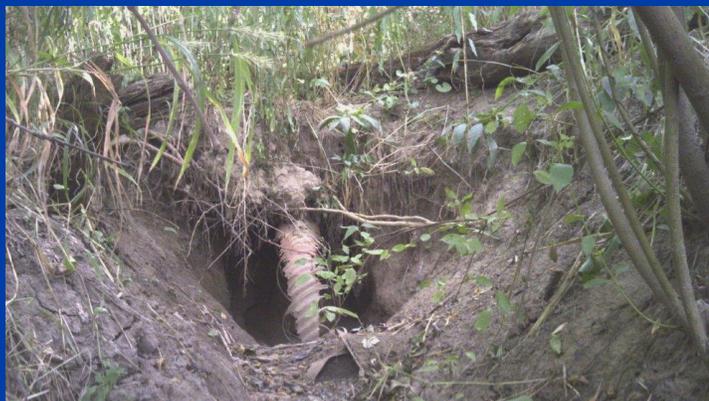
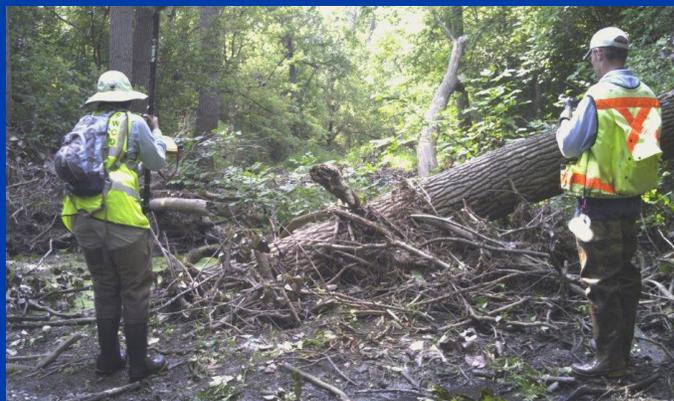
Debris, such as sediment and log jams, and streambank erosion inhibit the Feeder Channel from safely carrying flows from the surrounding watershed to the lake. During periods of flooding, this poses a risk to the farmers who own land along the channel and results in significant sediment and nutrient loading to Buckeye Lake. The degraded condition of the existing channel also eliminates the possibility of restoring the diversion of flow from the South Fork Licking River to the lake. Because the Feeder Channel represents a significant portion of the entire watershed area contributing flow to Buckeye Lake, any restoration of the channel will have measurable benefits to the lake. In fact, beyond improvements within the lake itself, the restoration of the Feeder Channel is one of the single highest priorities of many Buckeye Lake stakeholders.

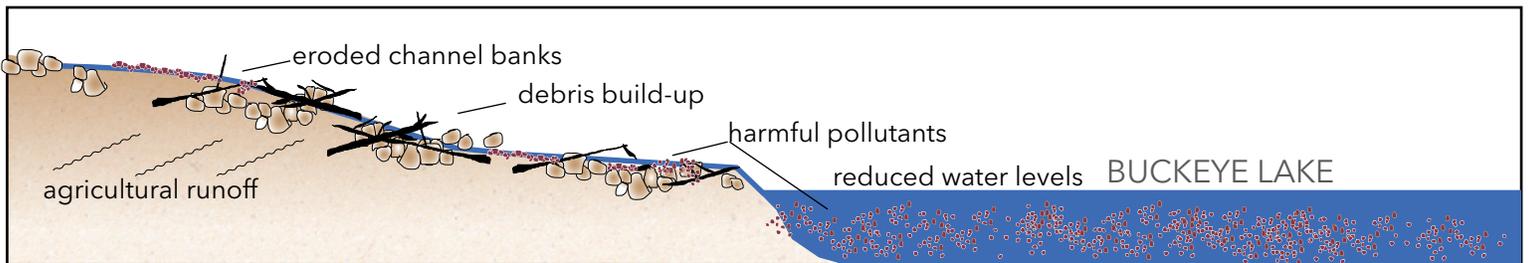
IMPAIRED CONDITION TODAY

Sediment build-up and harmful pollutant runoff in the form of nutrients via the Feeder Channel directly impacts the health of Buckeye Lake. Preserving the water quality of the lake is paramount to maintaining the health and safety of this public recreation amenity.
